Emergency Response Plan Documentation Report

12th Street Landfill
Plainwell, Michigan

July 2008

RMT, Inc. | Weyerhaeuser Company
Final

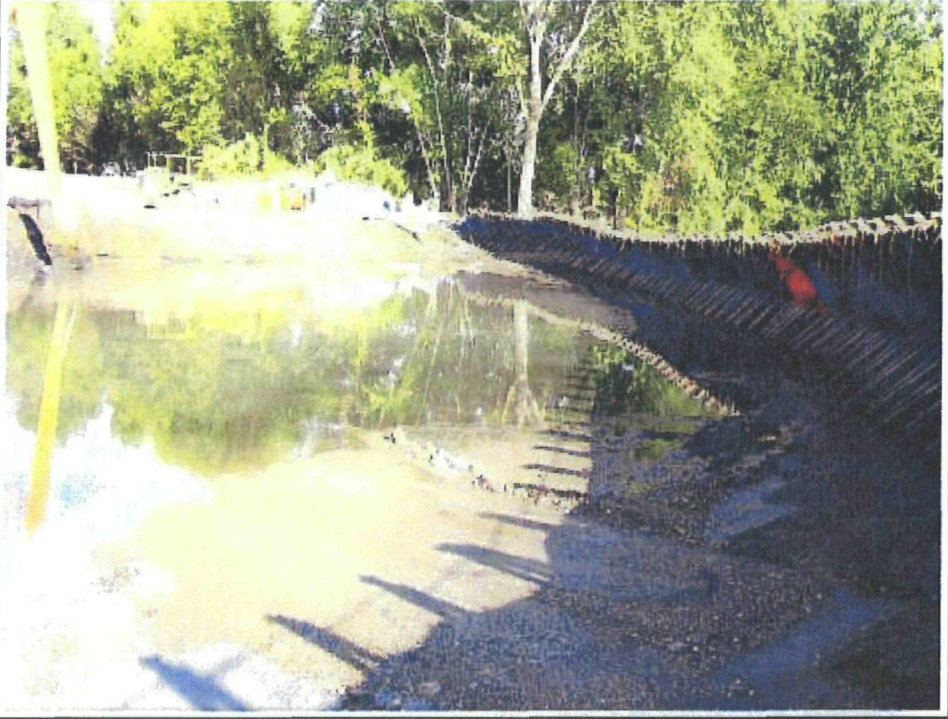
Client Name: Weyerhaeuser		Site Location: Plainwell, Michigan	Project No.: 00-05131.03
Photo No. 29	Date 9/08/2007

Description View of channel after excavation			
Photo No. 30	Date 9/9/2007

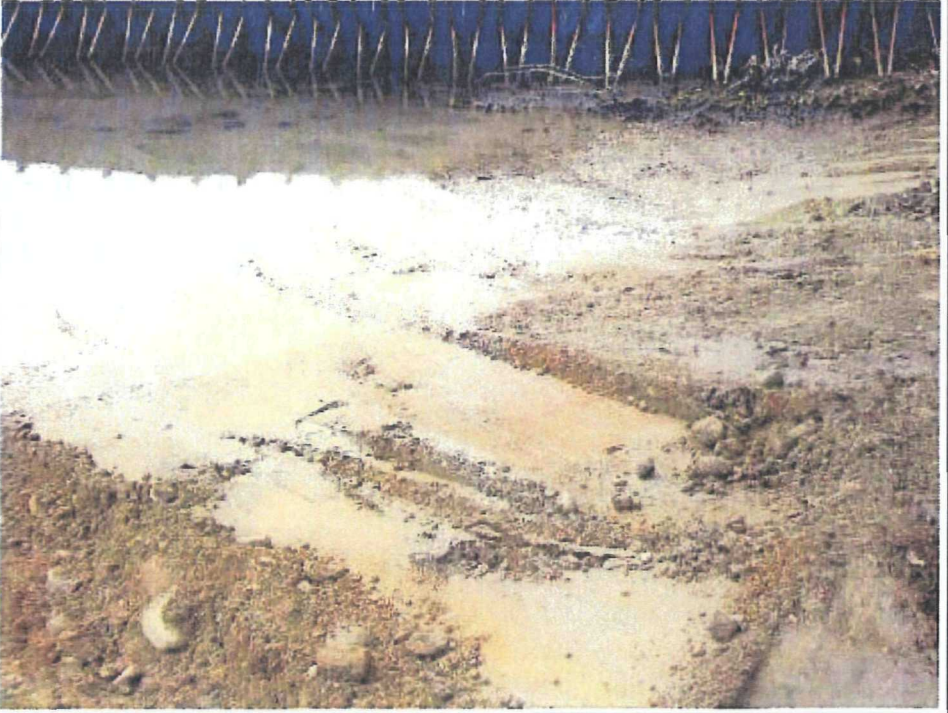
Description View of bank after excavation

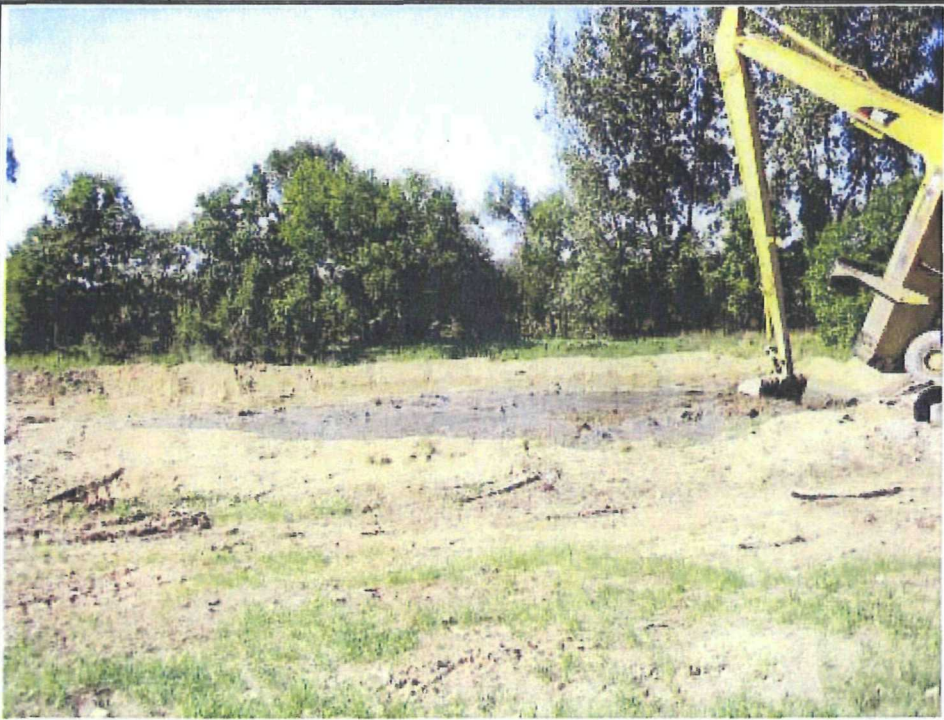
Client Name: Weyerhaeuser		Site Location: Plainwell, Michigan	Project No.: 00-05131.03
Photo No. 31	Date 9/10/2007

Description Containment/dewatering pad on top of landfill

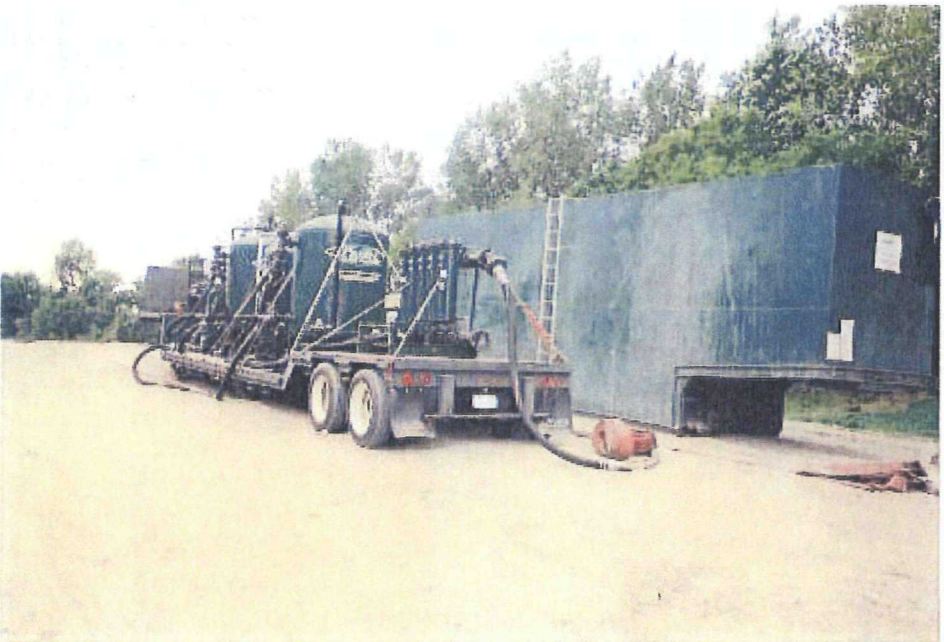
Photo No. 32	Date 9/9/2007

Description Water treatment holding tank and carbon system

An on-site wastewater treatment system consisting of a 20,000-gallon equalization/sedimentation holding tank, followed by bag filters and carbon adsorption columns was mobilized to the site and staged near the top of the landfill as noted on Figure 3. The multimedia filters and carbon columns were trailer-mounted and placed at the east top of slope of the landfill. General specifications of the wastewater treatment system are identified as:

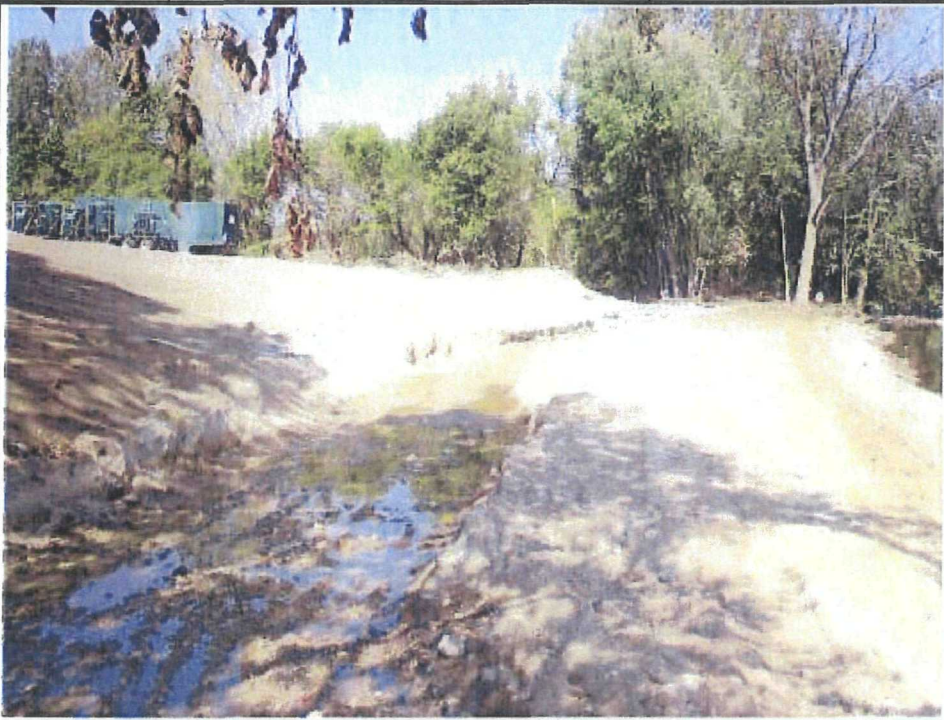
Client Name: Weyerhaeuser		Site Location: Plainwell, Michigan	Project No.: 00-05131.03
Photo No. 33	Date 9/19/2007

Description Excavation of clay plug trench

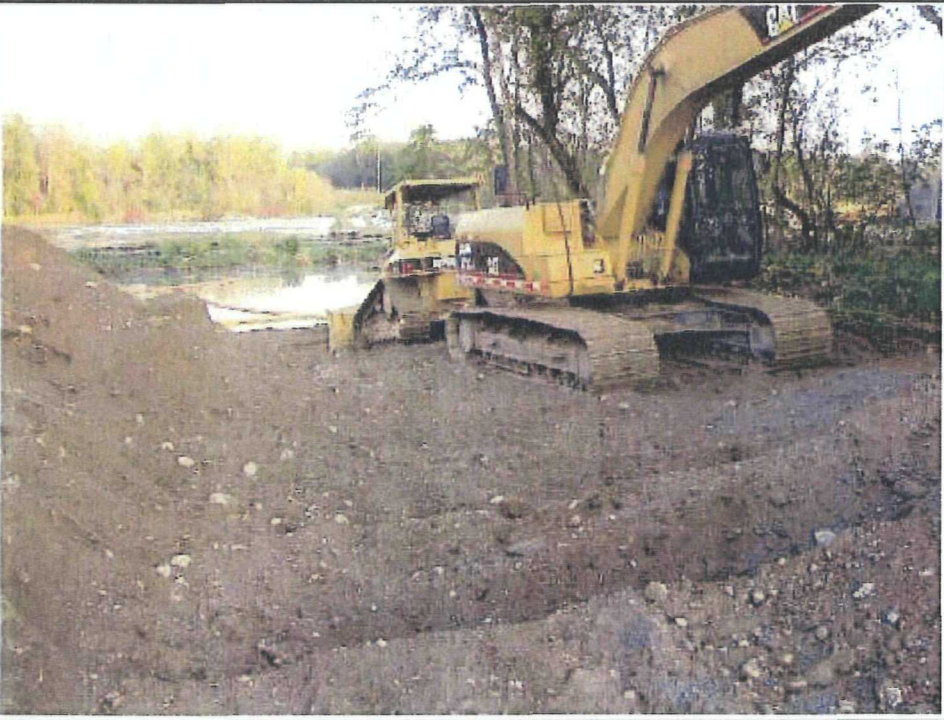
Photo No. 34	Date 9/25/2007

Description Trench installed along top of landfill to minimize any runoff down slope.

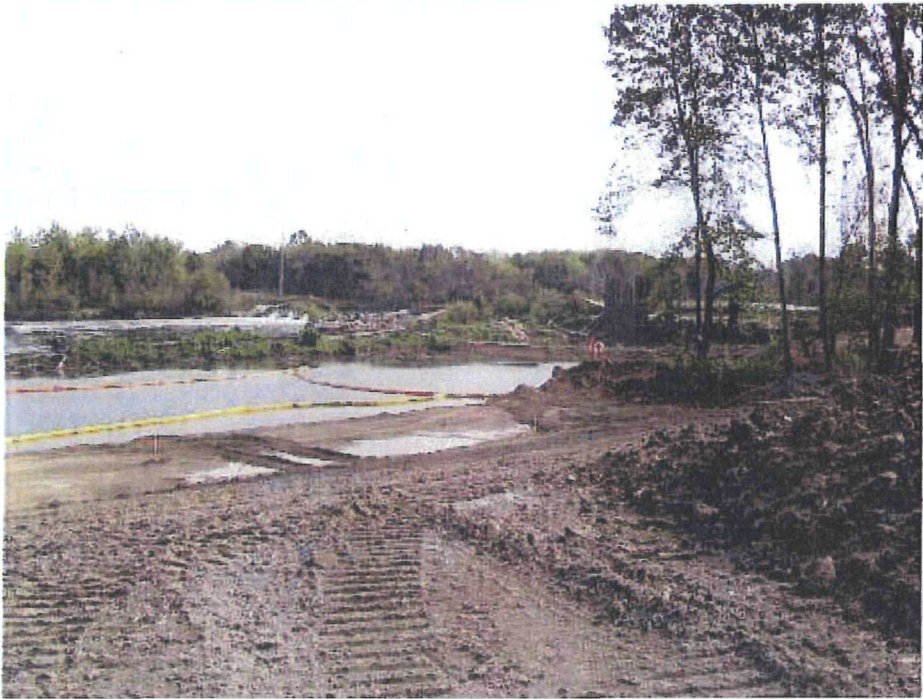
Client Name: Weyerhaeuser		Site Location: Plainwell, Michigan	Project No.: 00-05131.03
Photo No. 35	Date 9/27/2007

Description Preparing east face to 5:1 slope

Based on modeling results as identified in the Design Report and given the severe implications of slope failure for the eastern slope adjacent to the rerouted Kalamazoo River, a 5H to 1V slope was used for the slope from the access road to the top of landfill.

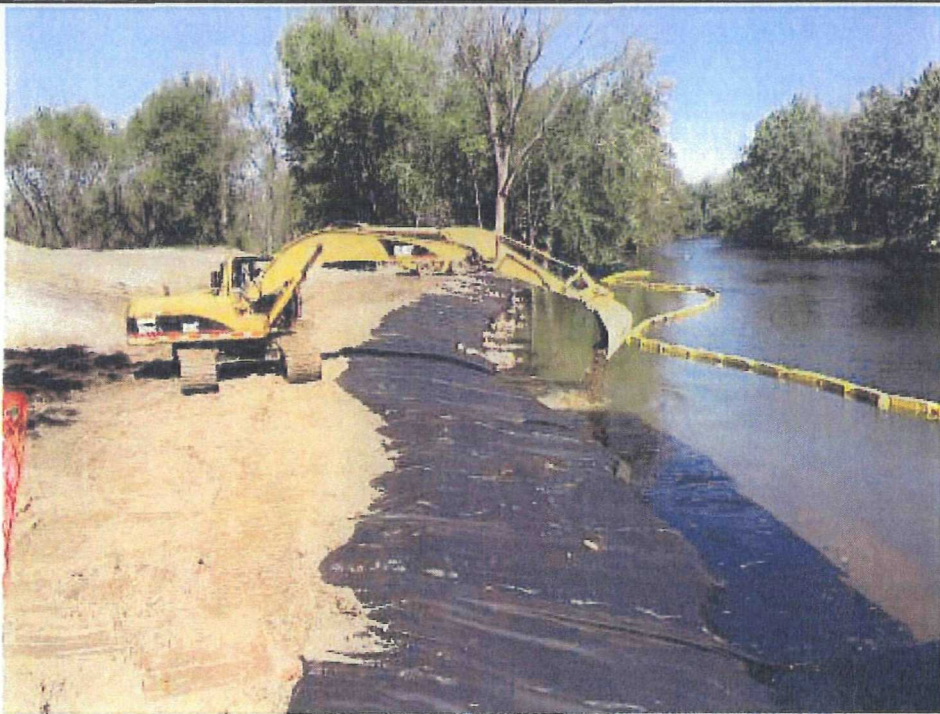
Photo No. 36	Date 10/9/2007

Description Placing stone within key trench at base of bank shoreline over geotextile fabric

Riverbank protection has been developed based upon resistance to the erosion from the rerouted Kalamazoo River through the former powerhouse channel and the impacts of ice and debris. The maximum flow velocity of the 500-year event along the 12th Street Landfill shoreline and landfill sideslope was estimated to be 5.7 feet per second (fps). The riprap erosion protection has also been designed to resist potential ice and debris (*e.g.*, fallen trees) damage. Riverbank protection will be provided by a minimum 2-foot lift (thickness) of specified riprap from the bottom of the river to the elevation of the access road at approximately 703 feet M.S.L. and by a turf reinforcement mat along the sideslope of the landfill, extending from the top of the riprap to elevation 707 feet M.S.L. The turf reinforcement mat will be capable of withstanding river velocities produced by a 500-year flood event (5.7 fps).

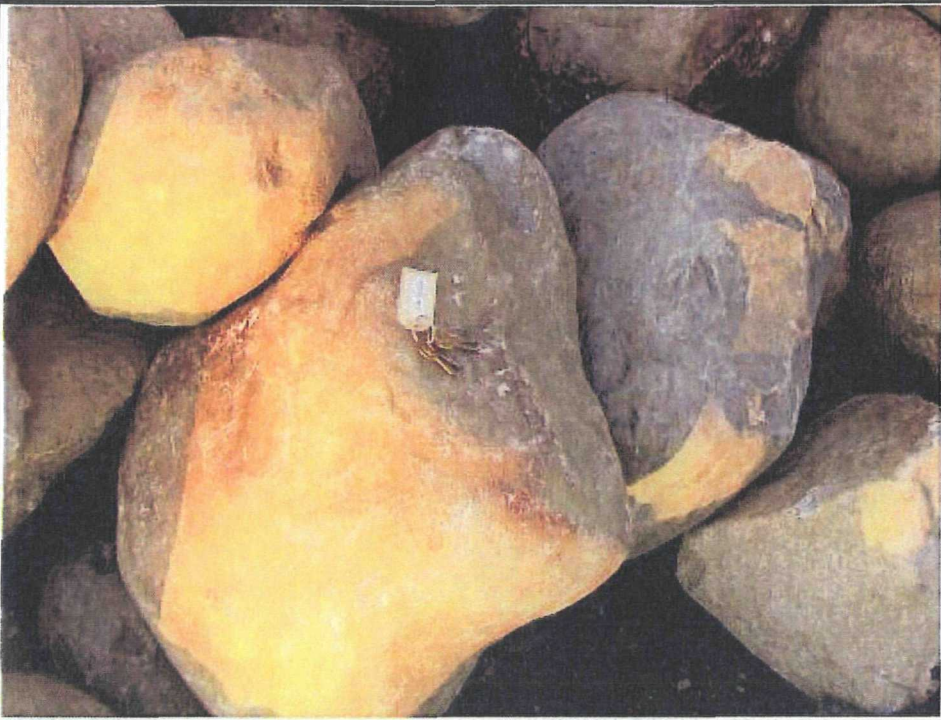
Client Name: Weyerhaeuser		Site Location: Plainwell, Michigan	Project No.: 00-05131.03
Photo No. 37	Date 10/9/2007

Description Closeup of stone prior to placement along shoreline

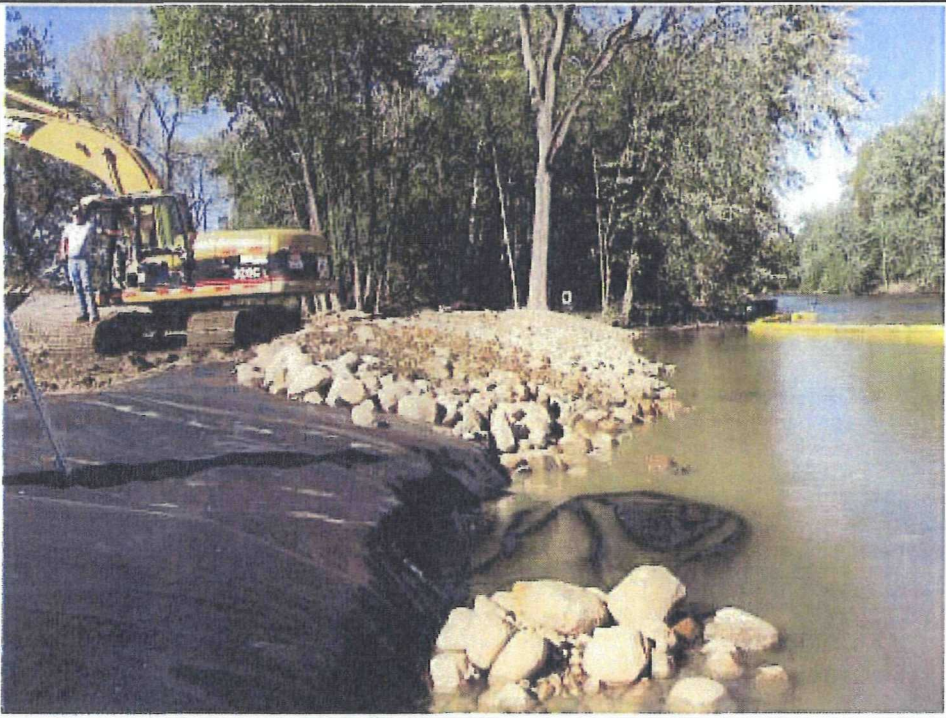
Photo No. 38	Date 10/9/2007

Description Placement of stone over geotextile

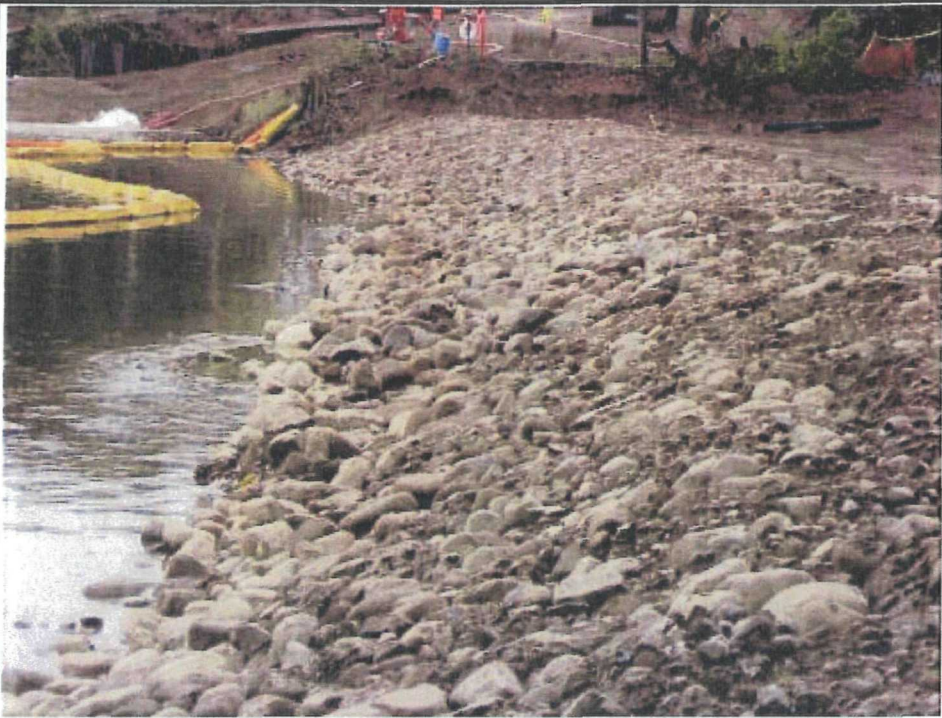
Client Name: Weyerhaeuser		Site Location: Plainwell, Michigan	Project No.: 00-05131.03
Photo No. 39	Date 10/10/2007

Description Shoreline after stone placement looking south

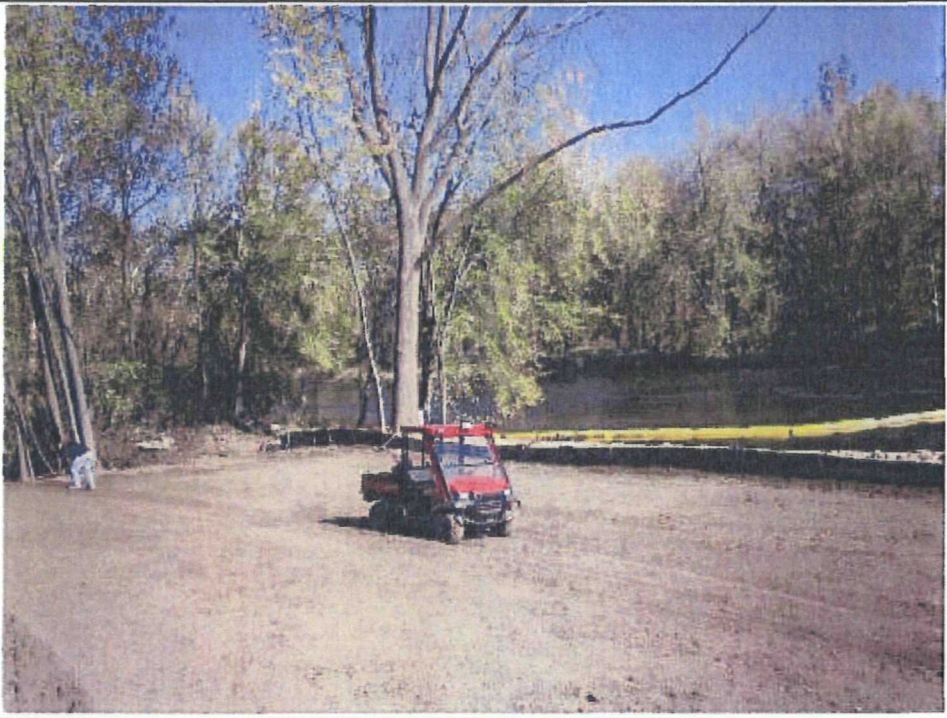
Photo No. 40	Date 10/22/2007

Description Prepare area for placement of Enkamat material

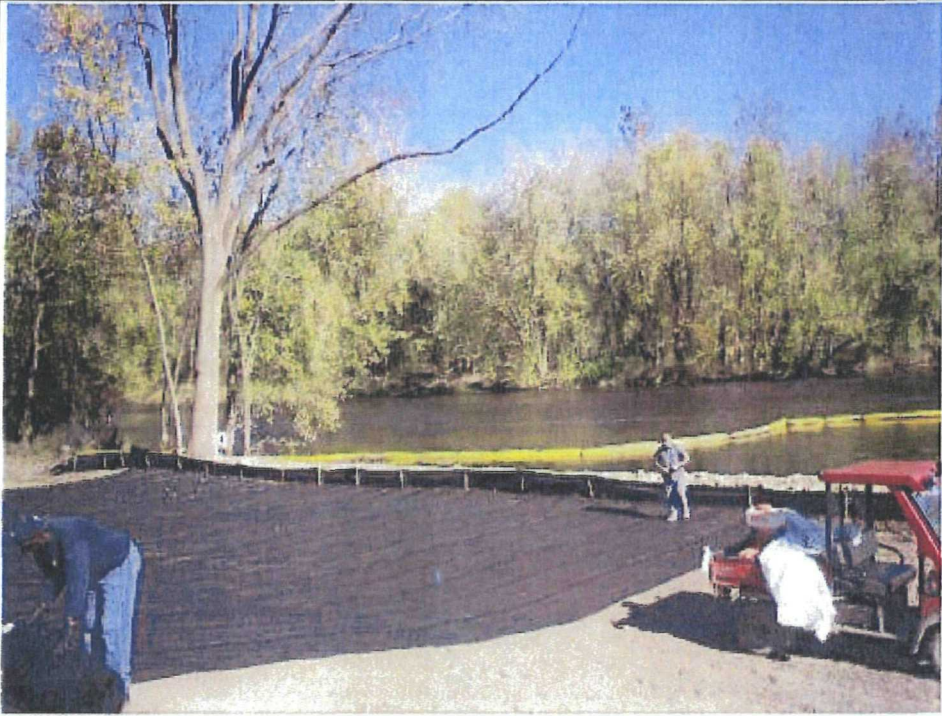
Client Name: Weyerhaeuser		Site Location: Plainwell, Michigan	Project No.: 00-05131.03
Photo No. 41	Date 10/23/2007

Description Placement of Enkamat along slope

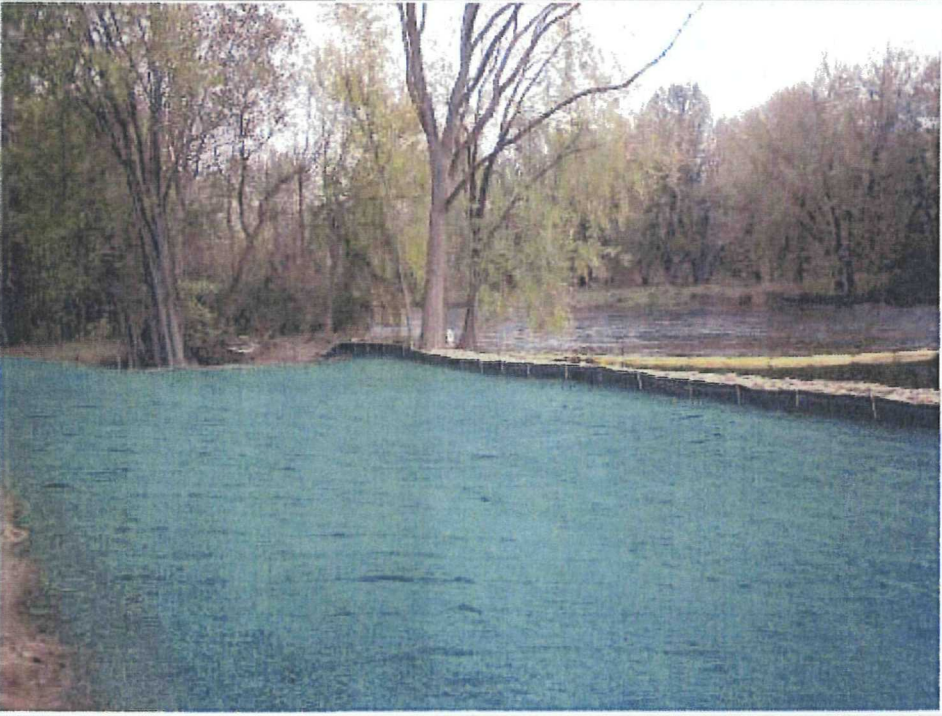
Photo No. 42	Date 10/25/2007

Description Enkamat after hydroseeding

All disturbed areas will either be seeded and mulched, or hydro-seeded based on field conditions. Fertilizer will be applied only if needed. The area where the turf reinforcement mat is placed will be hydro-seeded after installation. To help establish a more natural look along the river, willow stalks may be planted along the river's edge within the riprap.

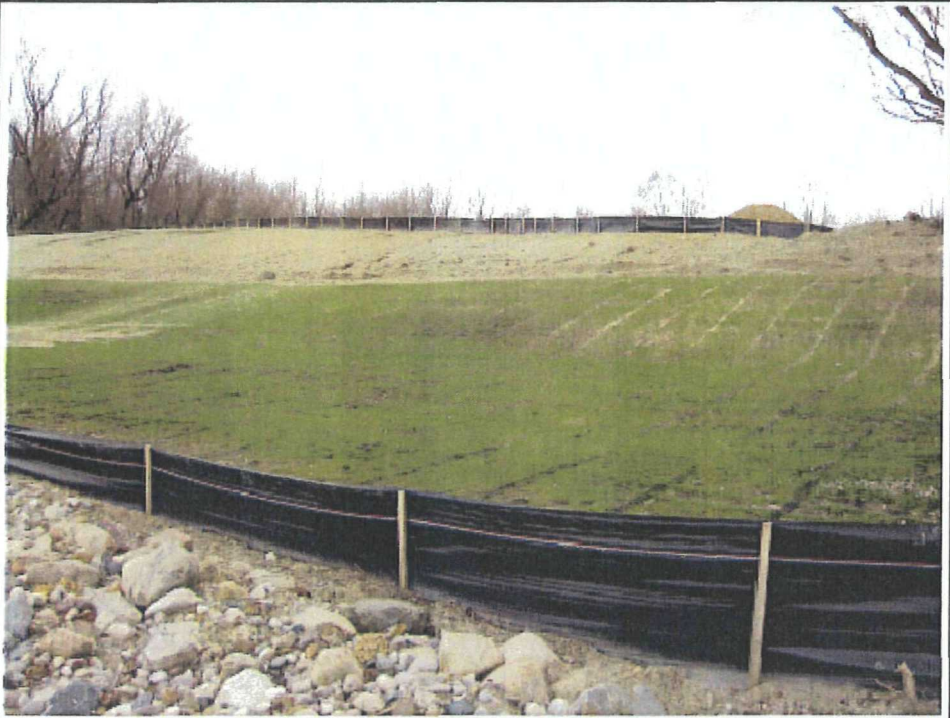
Client Name: Weyerhaeuser		Site Location: Plainwell, Michigan	Project No.: 00-05131.03
Photo No. 43	Date 4/8/2008

Description East face of landfill with vegetative growth – silt fence placed at top of bank

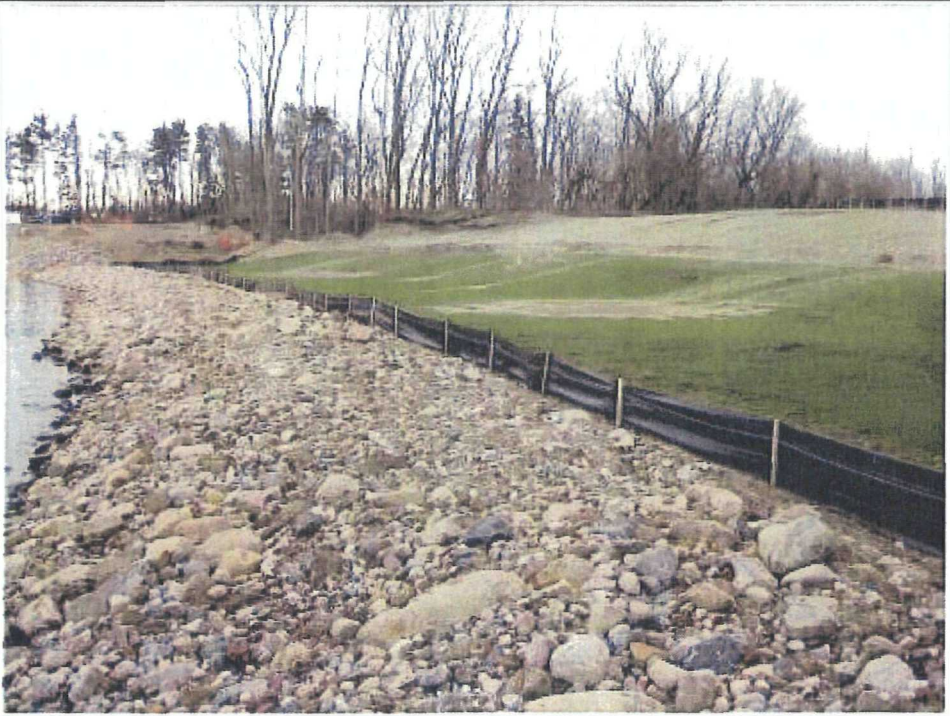
Photo No. 44	Date 4/10/2008

Description View of shoreline looking south after initial opening of flow through former powerhouse channel

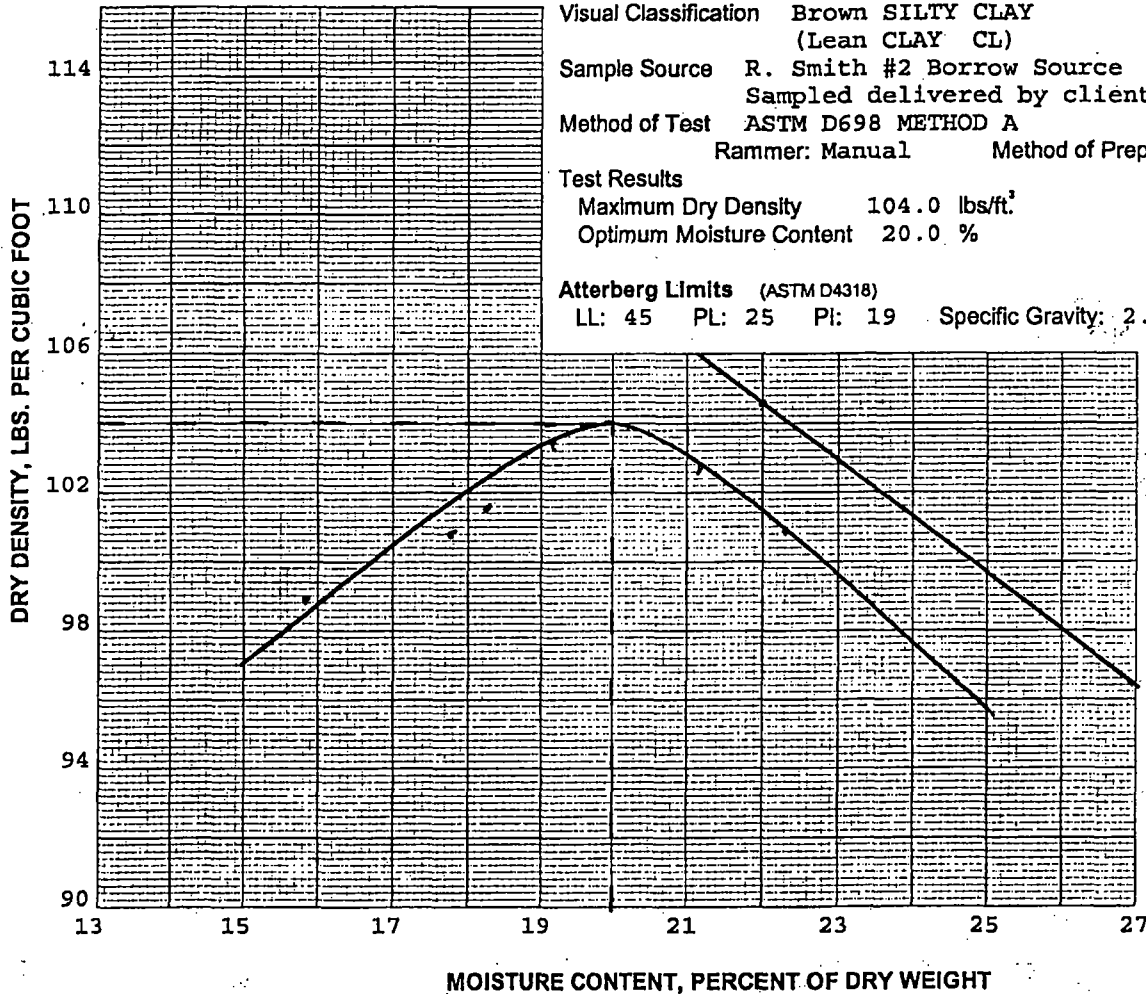
REPORT OF MOISTURE DENSITY RELATIONSHIP OF SOIL

Visual Classification Brown SILTY CLAY
(Lean CLAY CL)
Sample Source R. Smith #2 Borrow Source
Sampled delivered by client to PSI
Method of Test ASTM D698 METHOD A
Rammer: Manual Method of Preparation: Moist
Test Results
Maximum Dry Density 104.0 lbs/ft.³
Optimum Moisture Content 20.0 %
Atterberg Limits (ASTM D4318)
LL: 45 PL: 25 PI: 19 Specific Gravity: 2.65 (estimate)

Grain Size Analysis (ASTM C136 and/or C117)	
Sieve Size	Percent Passing
No. 4	100
No. 8	99.8
No. 10	99.7
No. 16	99.6
No. 30	99.2
No. 50	96.7
No. 100	92.4
No. 200	90.9
